LEARNING OBJECTIVES

- Understand the building science fundamentals of rainwater management, vapor diffusion and air leakage control.
- Understand the use of hygrothermal evaluation of building enclosure assemblies in developing climate appropriate enclosure assemblies.
- Review case studies and understand how small oversights can lead to large failures
- Learn how to evaluate the continuity and detailing of building enclosure control layers
- Understand key risk management steps from design through construction

PROACTIVE RISK MANAGEMENT

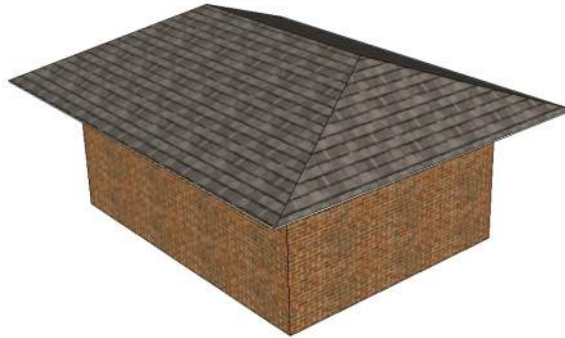
4Ds of Rainwater Management

1. Deflection
2. Drainage
3. Drying
4. Durability

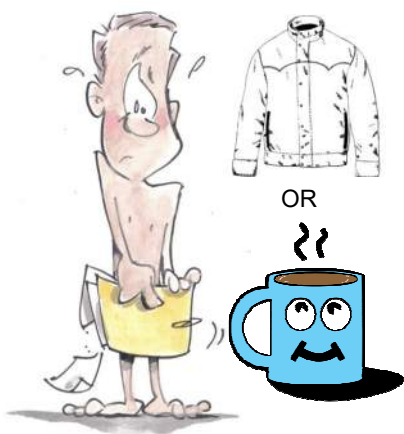
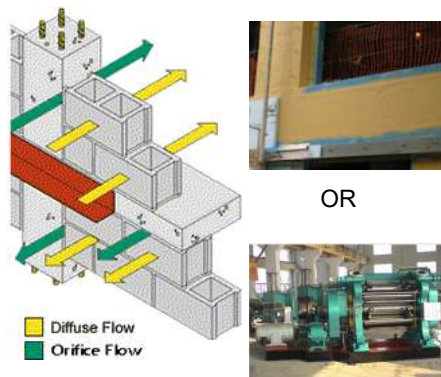
Air Leakage Control

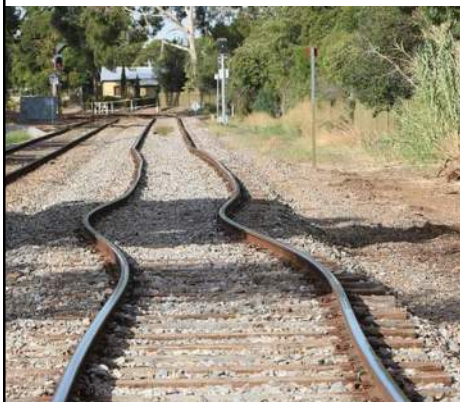
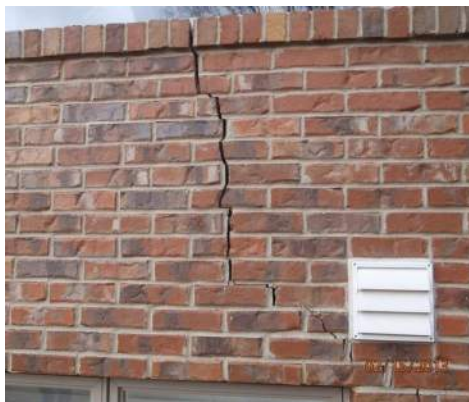
Thermal Movement

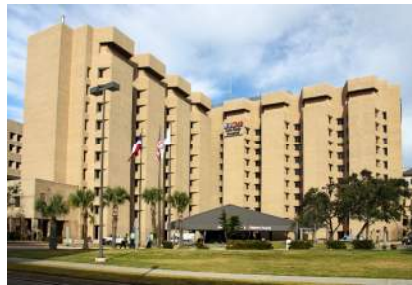
University of Texas Medical Building

Recladding

Brick, curtain wall, metal rain screen panels, cast stone

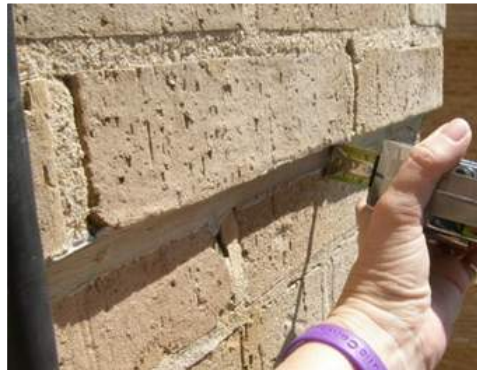
Failure at concrete beam

Distress at sloped brick sills

Outward displacement of brick veneer

Coastal Environment

Corroded

- reinforcement steel
- shelf angles and lintels
- brick ties

→ Failure

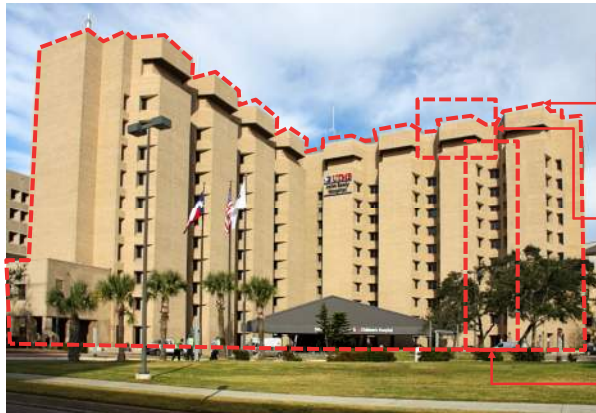
Replace brick veneer & install air/water barrier

Metal cladding with exterior aluminum frame

Partial infill & curtain wall

1. Brick demolition
 2. Backup wall remediation
 3. Air/water/vapor barrier
 4. New cladding
- Unreinforced CMU is structurally deficient
 - Cannot anchor new cladding to unreinforced CMU
 - New exterior aluminum structure anchored to existing floor slabs

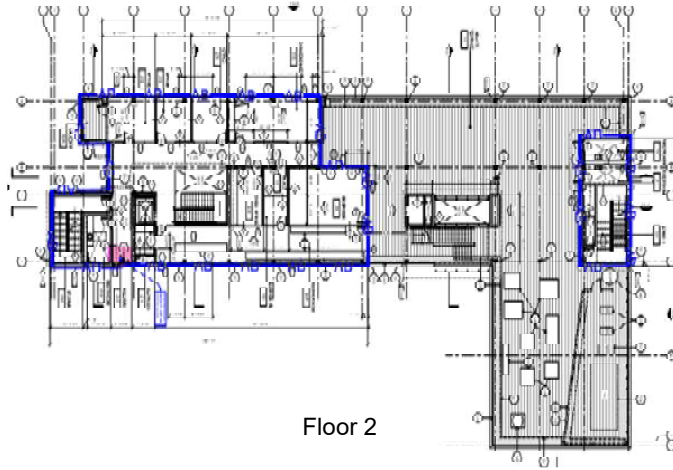
Floor 2

What's Inside, What's Outside?

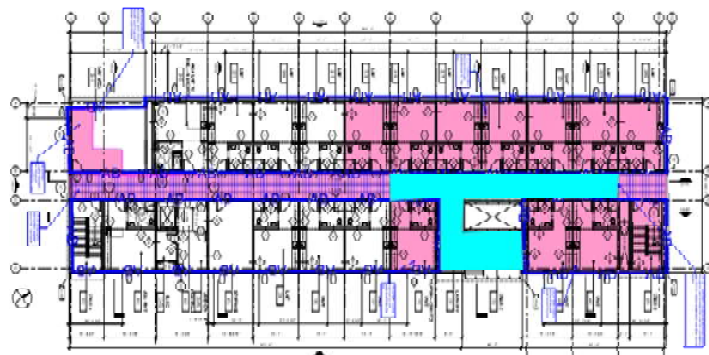
Floor 3

What's Inside, What's Outside?

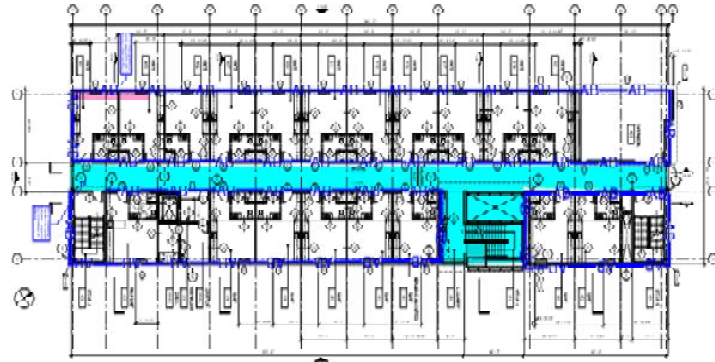
Floor 4

What's Inside, What's Outside?

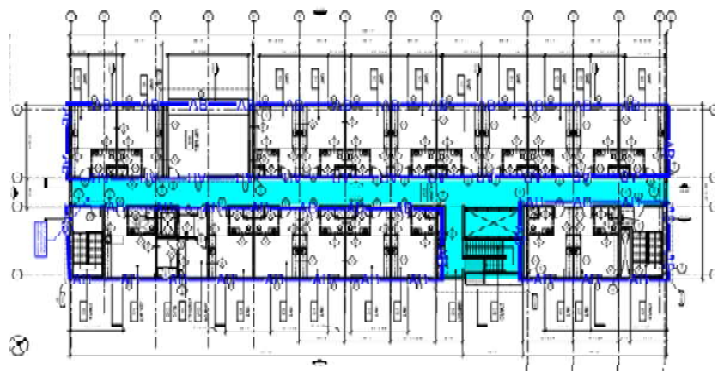
Floor 5

What's Inside, What's Outside?

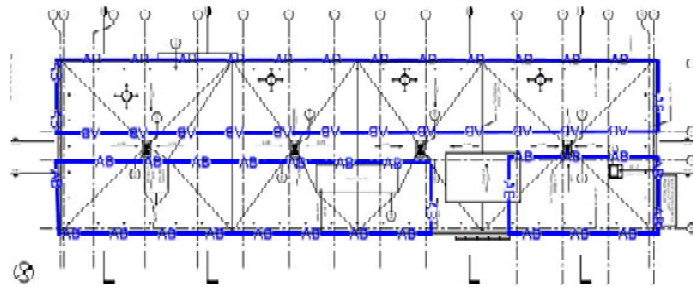
Roof

What's Inside, What's Outside?

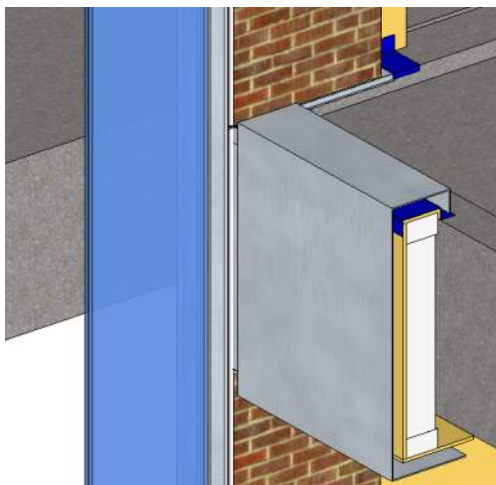
Complex Interfaces – Office Tower

Virtual Mockup

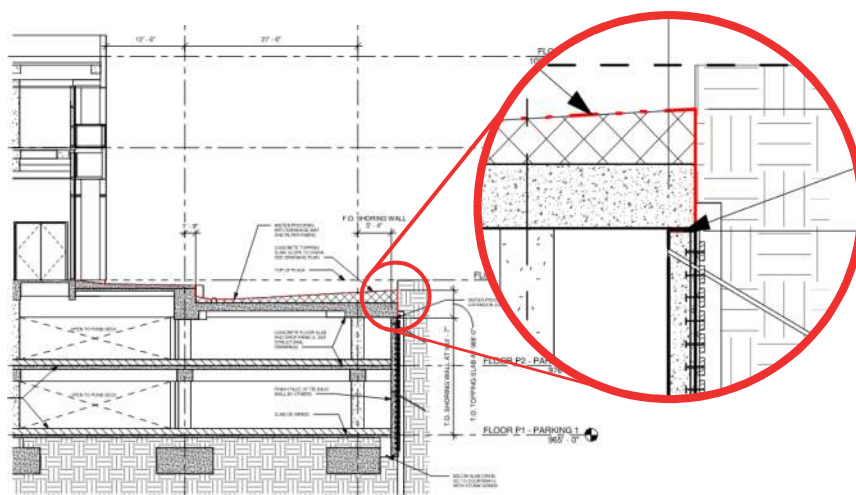
Complex Interfaces – CIP deck and shotcrete wall

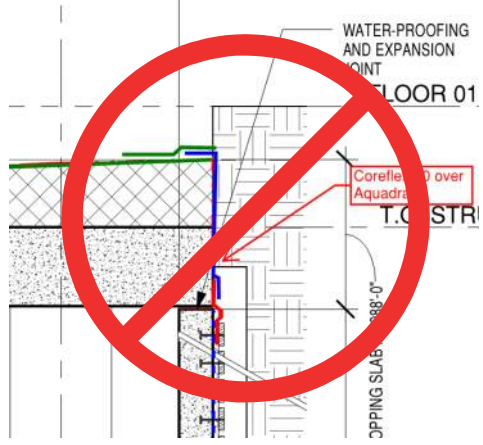
Vertical Expansion Joint

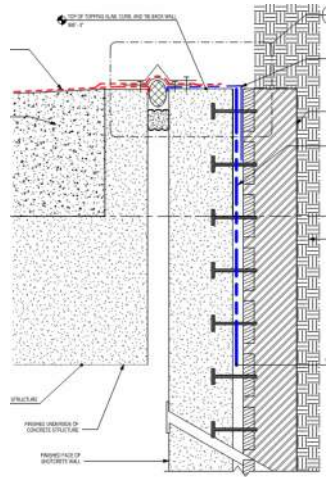
Solution

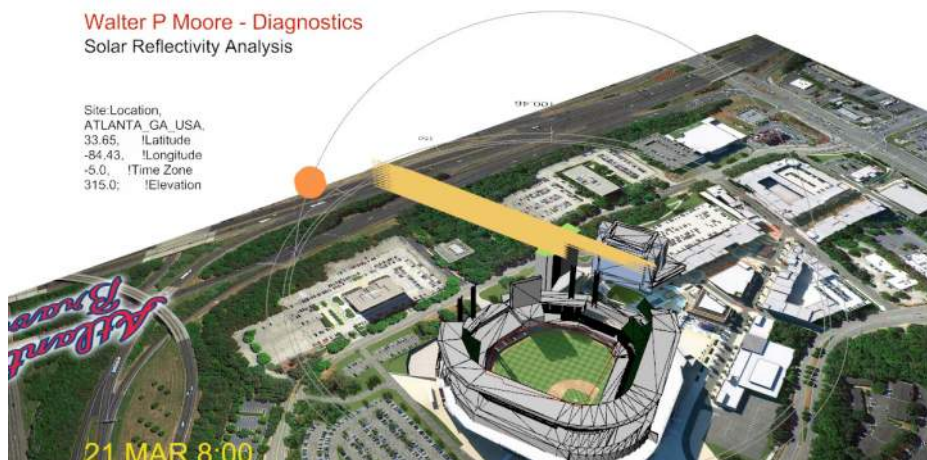
Walter P Moore - Diagnostics
Solar Reflectivity Analysis

Site Location,
ATLANTA, GA, USA,
33.65, !Latitude
-84.43, !Longitude
-5.0, !Time Zone
315.0, !Elevation

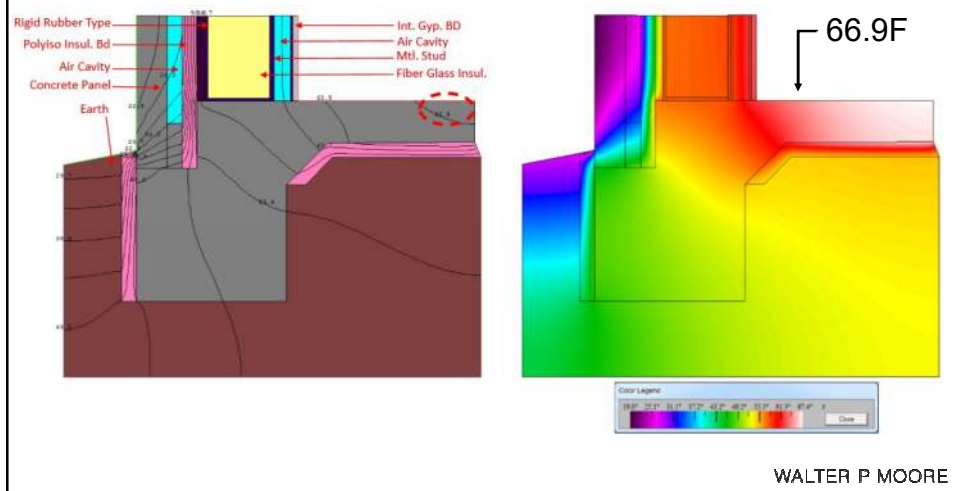
Thermal Bridging Study

Modified Foundation & Insulation

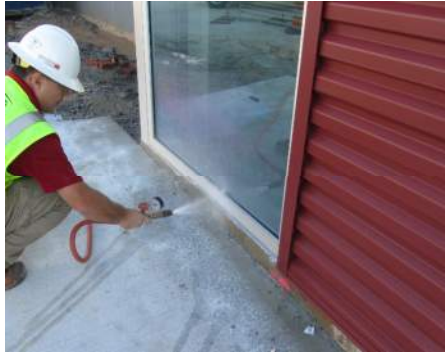
AAMA 501.2
Nozzle Test

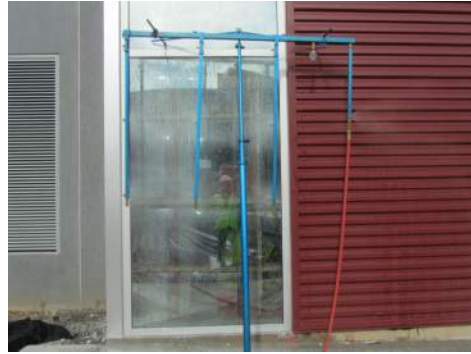
ASTM E1105
Spray Rack Test
